**Coastal Protection and Restoration
Authority of Louisiana (CPRA)**

2016/2017 Annual Inspection Report

HWY 384 HYDROLOGIC RESTORATION PROJECT (CS-21)

March 23, 2017
Cameron Parish

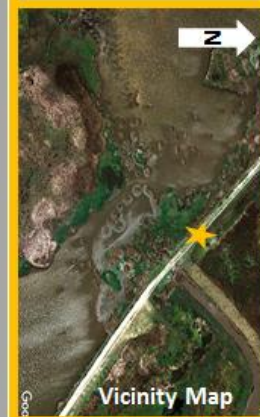
Photo No. 12, Vegetation Changes Over Time (2017): Project Interior – Northwest of Structure No. 1

Project Interior
taken Northwest
of Structure No.
1 on levee road.

Water was high in
2016 and low in
2017 but the
changes in the
marsh elevation
are still evident.
